Appendix 6.C Aquatic Assessment Results

Section 2 includes photos (Figure 2 to Figure 24) of the ten sample sites.

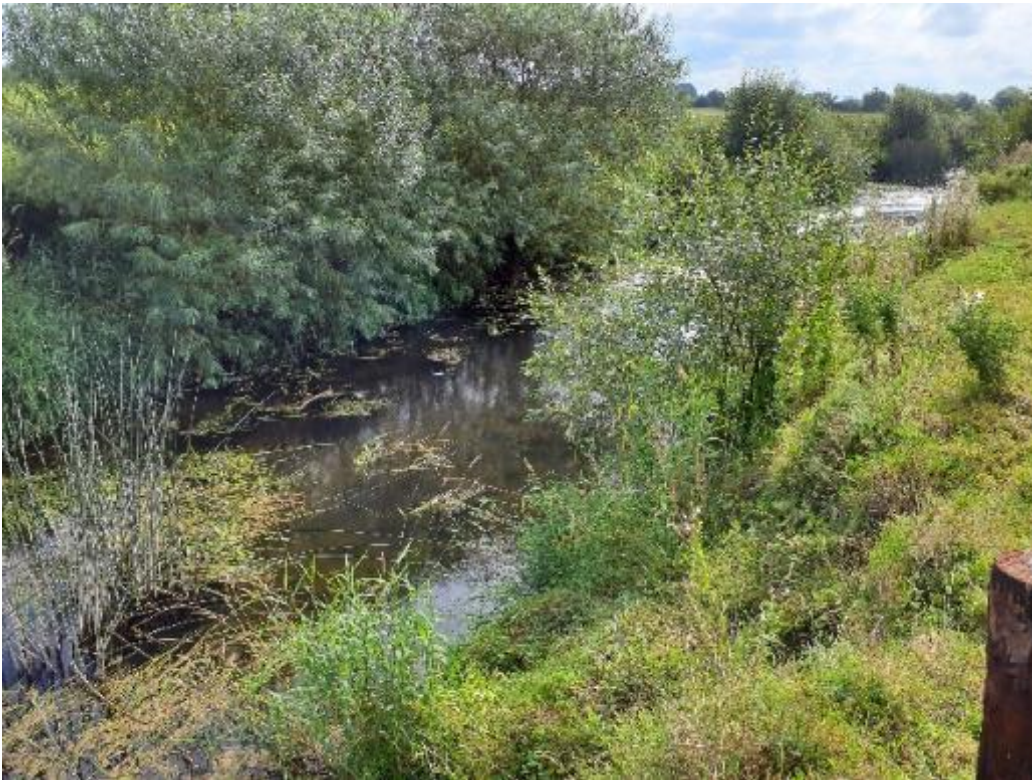
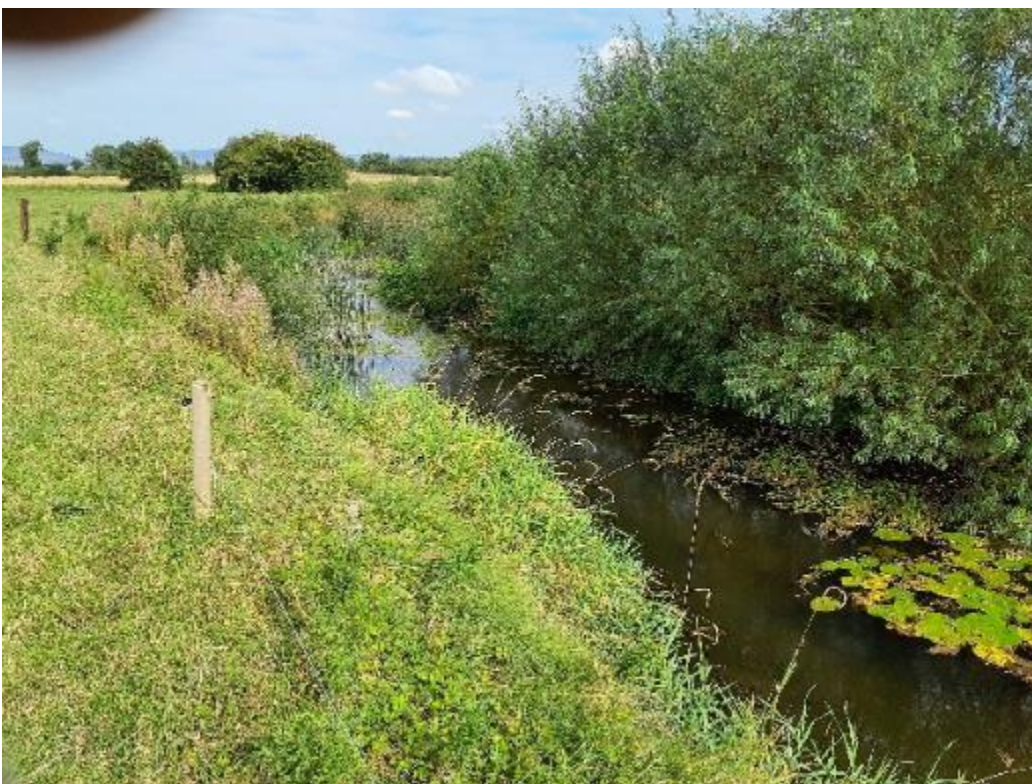
Figure 1: WQ1 in the River Suir

Figure 1 and Figure 2 show the condition of the River Suir for the first sampling point (WQ1). This sample point had group C indicator species present, which are tolerant of pollutants in the water. This sample point scored a Q

value of Q3, which means the water quality is poor. The Water Framework Directive (WFD) status of this sample point is poor.

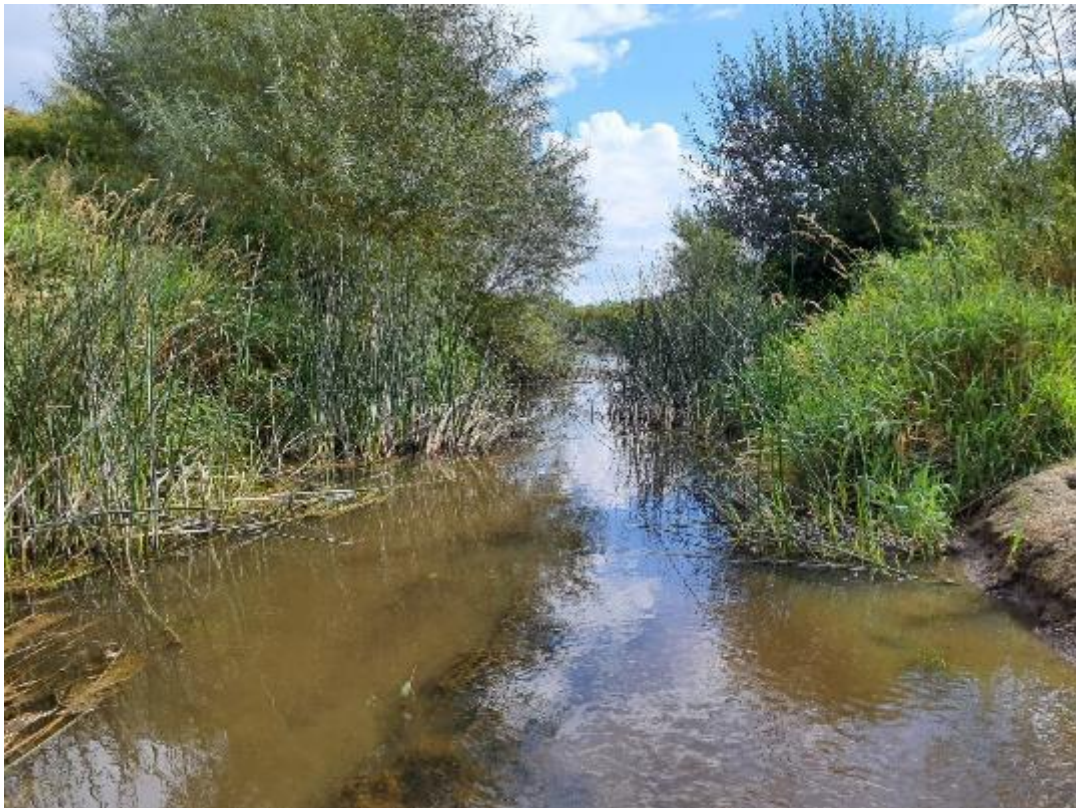
Figure 6: WQ3 in the River Suir

Figure 6 and Figure 7 show the condition of the River Suir for WQ3 sampling point. This sample point had group B indicator species present, which are sensitive of pollutants in the water. This sample point scored a Q value of

Q3-4, which means the water quality is moderate. The Water Framework Directive (WFD) status of this sample point is moderate. Figure 8 shows the surveyor setting the crayfish trap in the River Suir at WQ3 sample point.

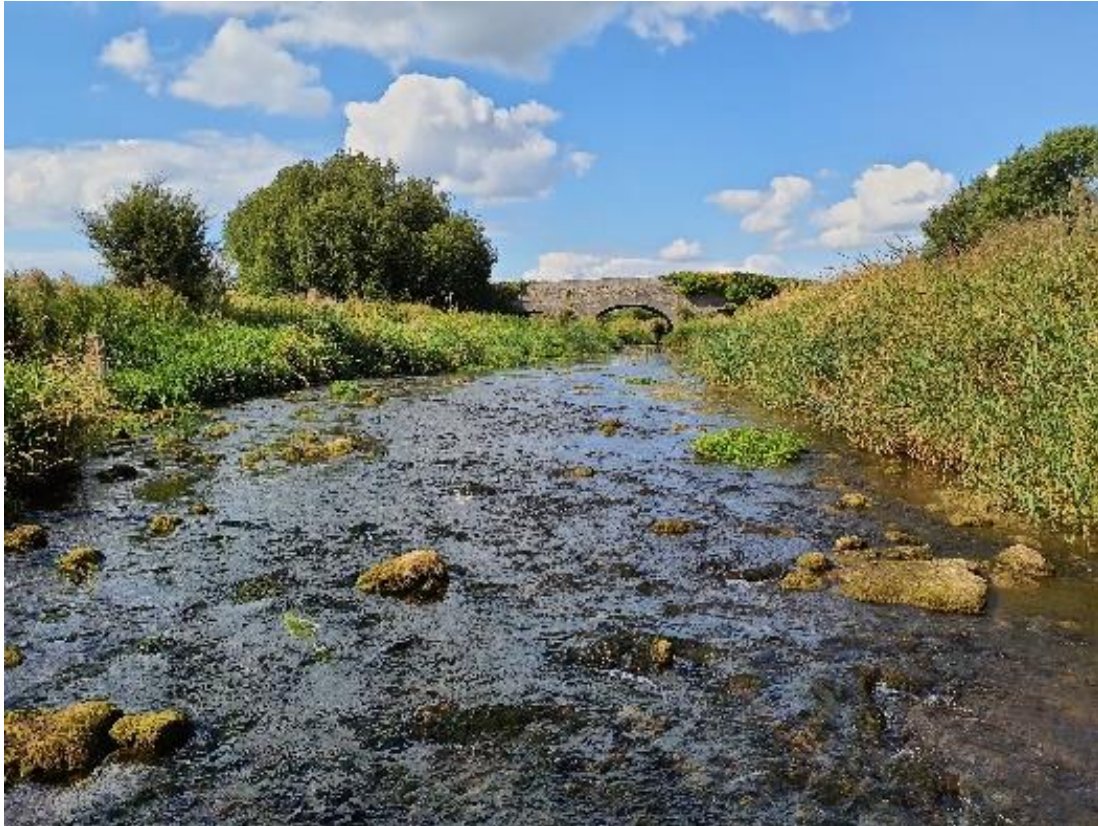
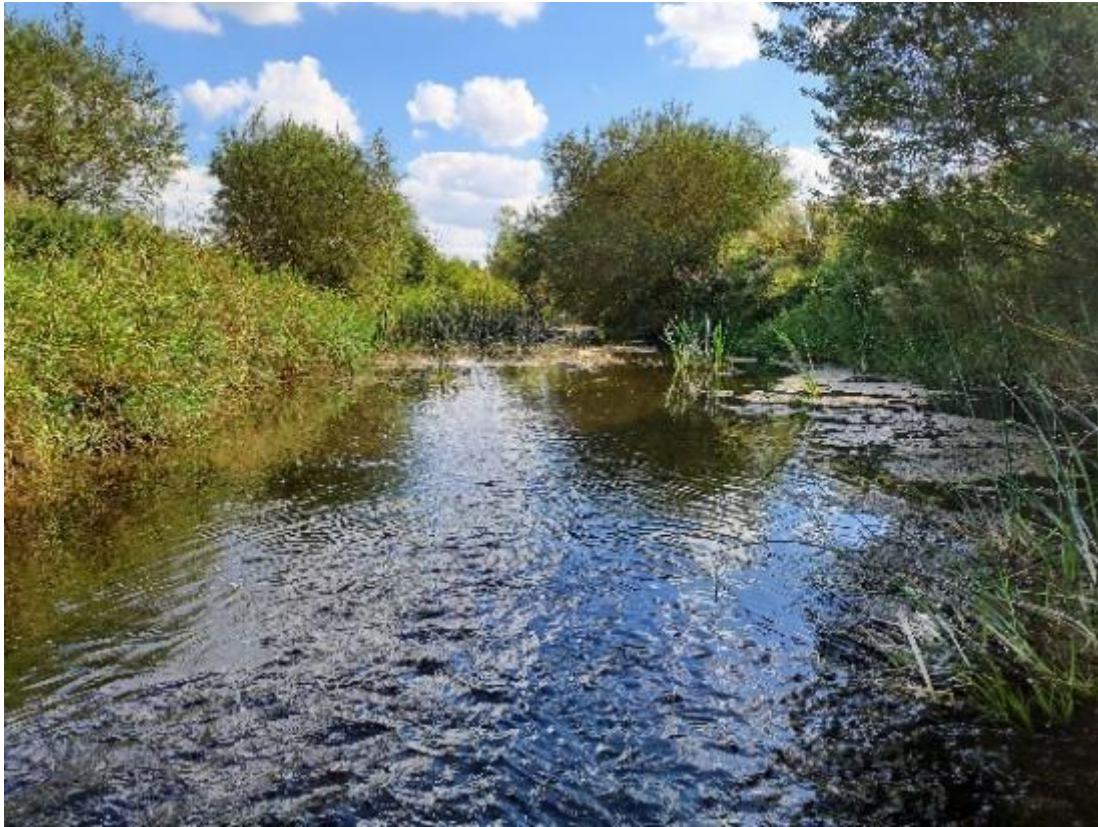
Figure 11: WQ5 in the River Suir

Figure 11 and Figure 12 show the condition of the River Suir for WQ5 sampling point. This sample point had group B indicator species present, which are sensitive of pollutants in the water. This sample point scored a Q value of Q3-4, which means the water quality is moderate. The Water Framework Directive (WFD) status of this sample point is moderate.

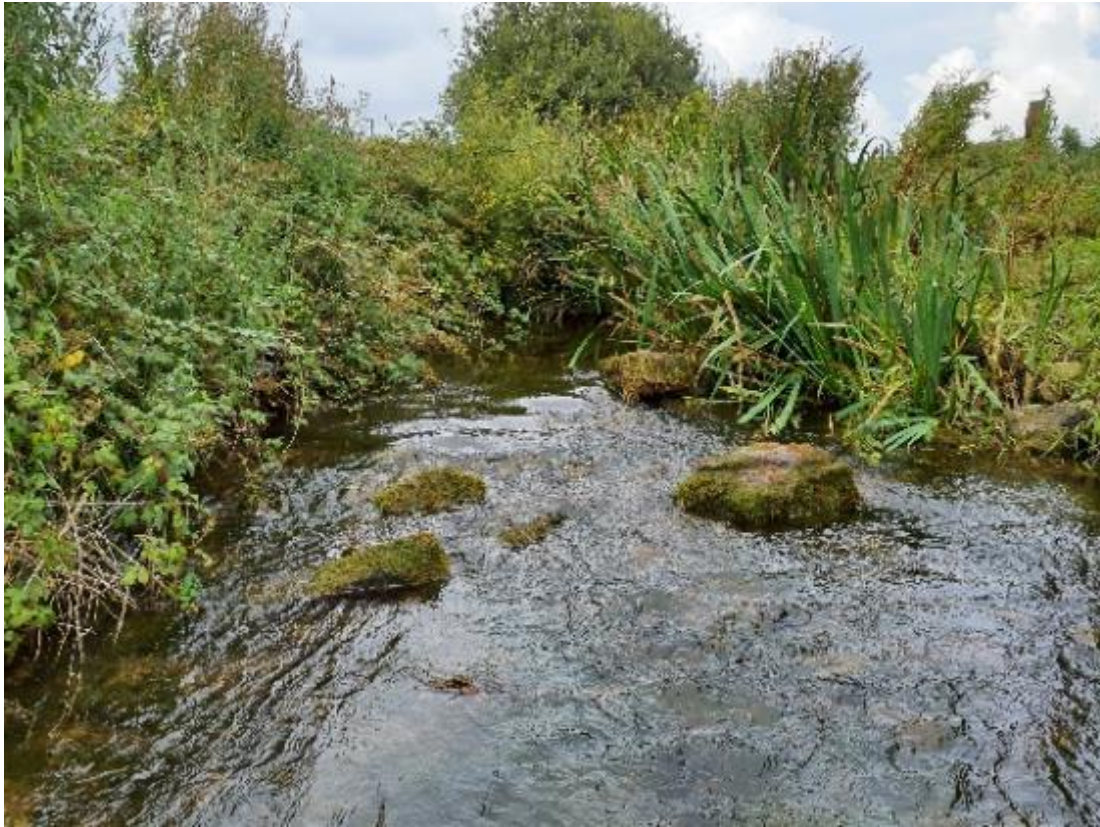
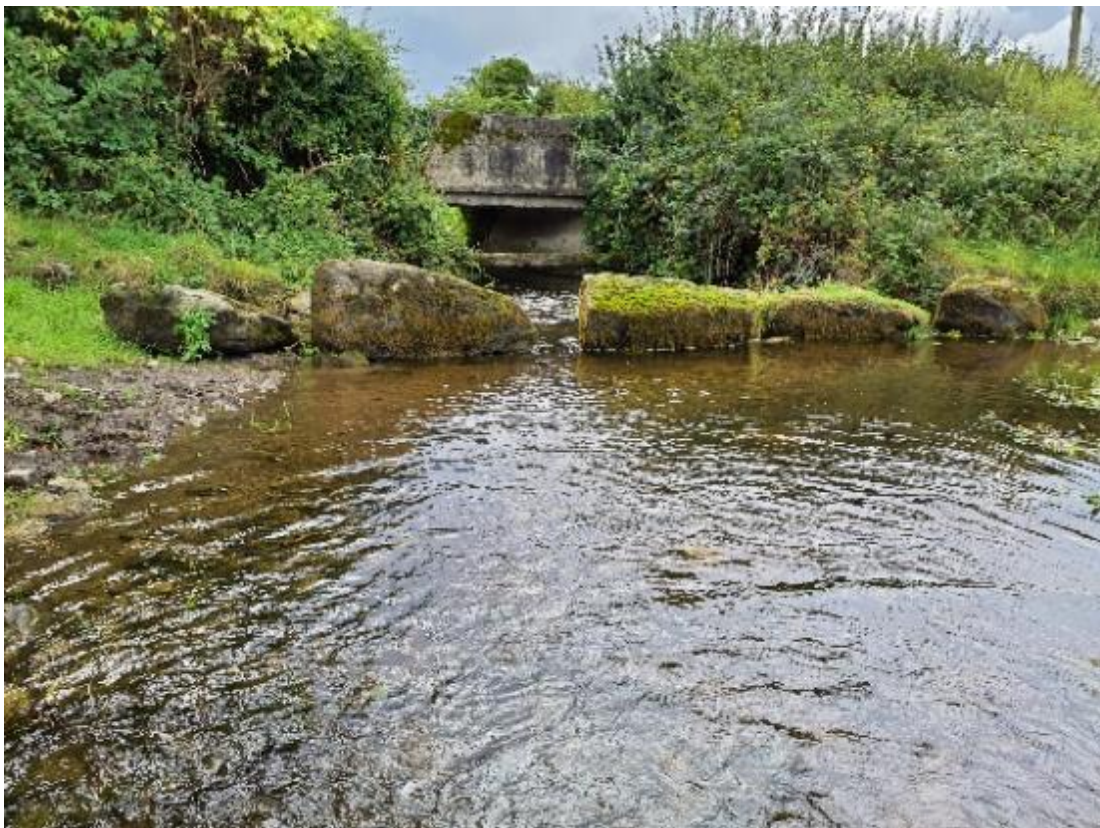
Figure 13: WQ6 in the Rossesstown River

Figure 13 and Figure 14 show the condition of the Rossesstown River for WQ6 sampling point. This sample point had group C indicator species present, which are tolerant of pollutants in the water. This sample point scored a Q

value of Q3, which means the water quality is poor. The Water Framework Directive (WFD) status of this sample point is poor.

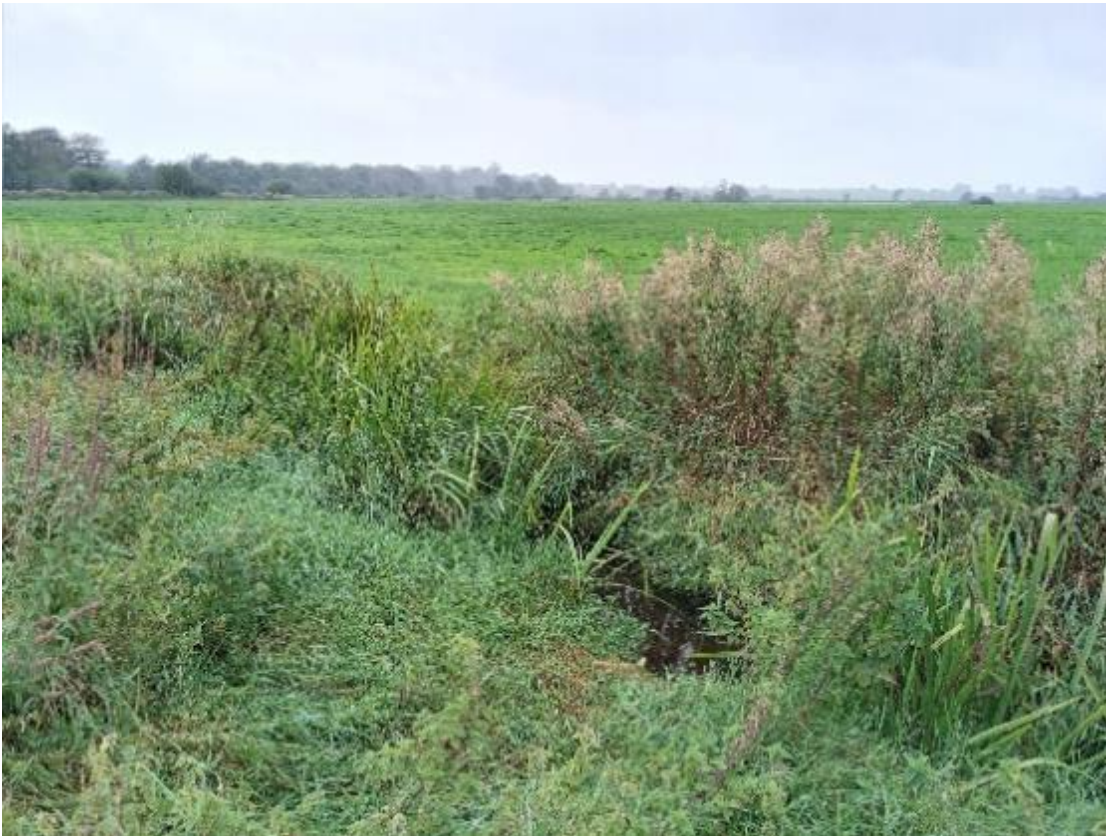
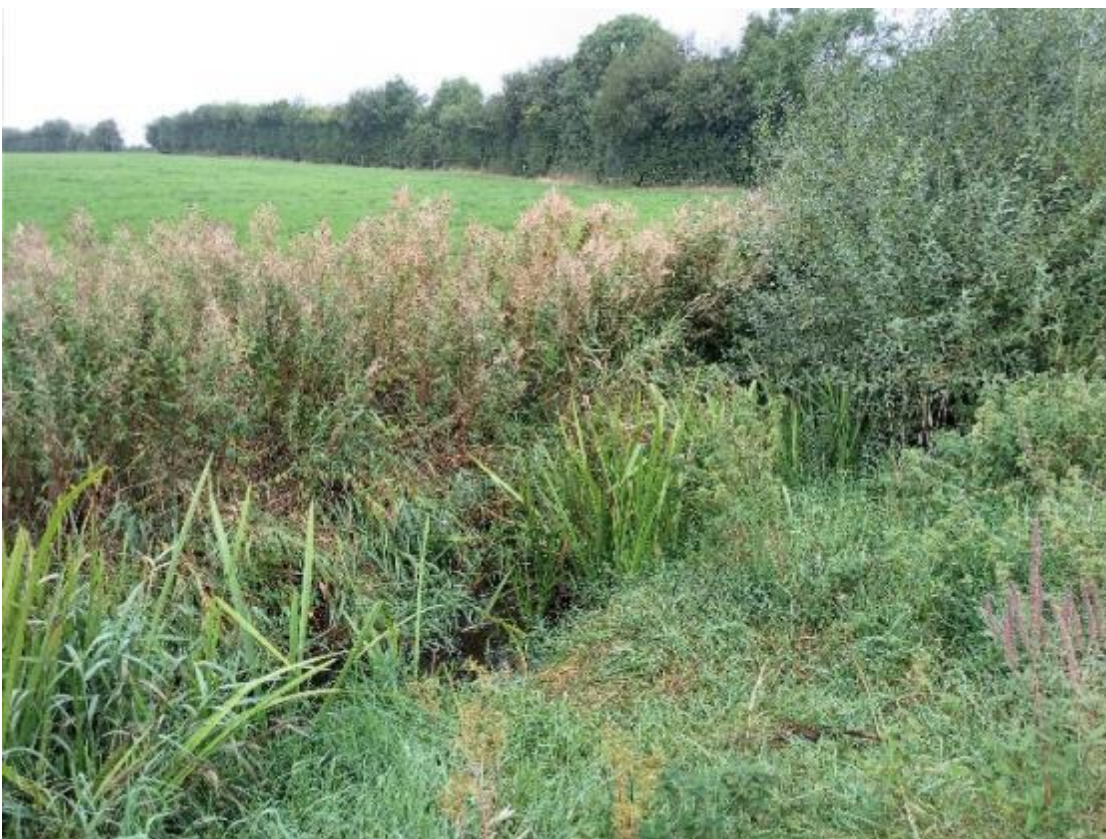
Figure 15: WQ7 in the Rossesstown River

Figure 15 and Figure 16 show the condition of the Rossestown River for WQ6 sampling point. This sample point had group C indicator species present, which are tolerant of pollutants in the water. This sample point scored a Q value of Q3, which means the water quality is moderate. The Water Framework Directive (WFD) status of this sample point is poor.

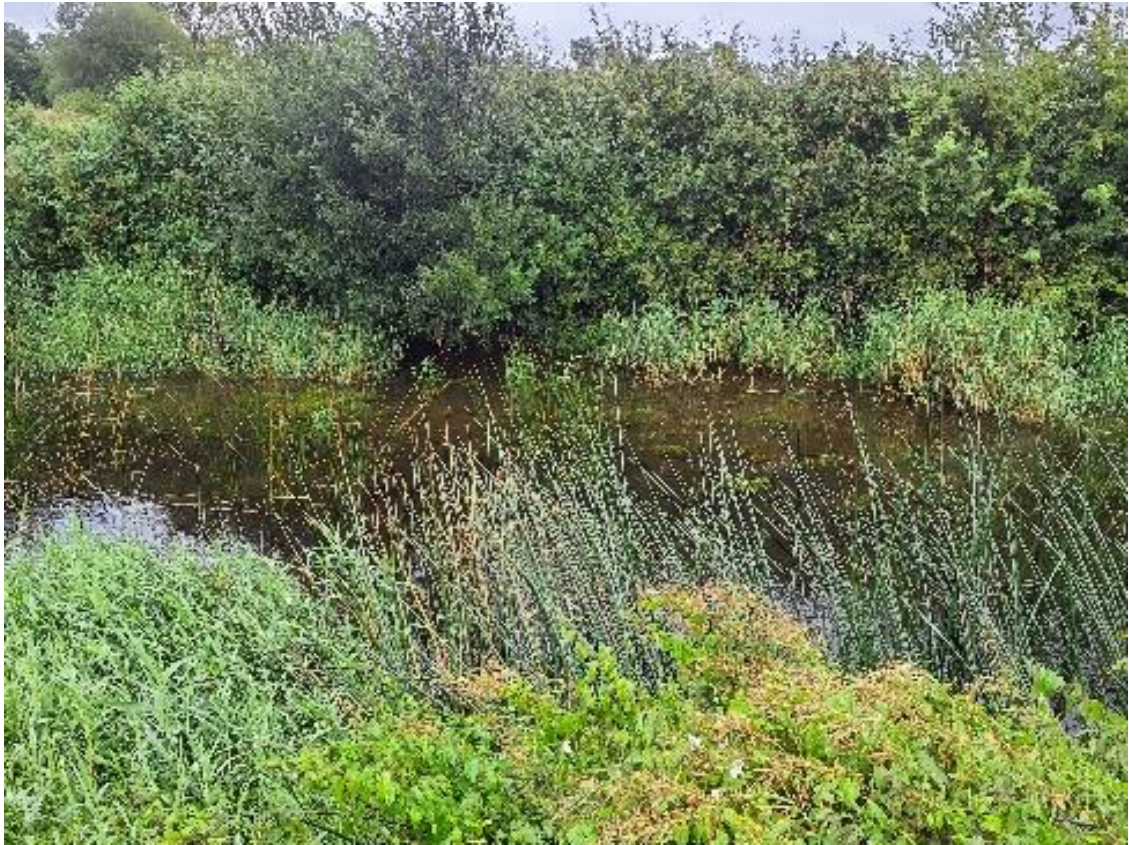
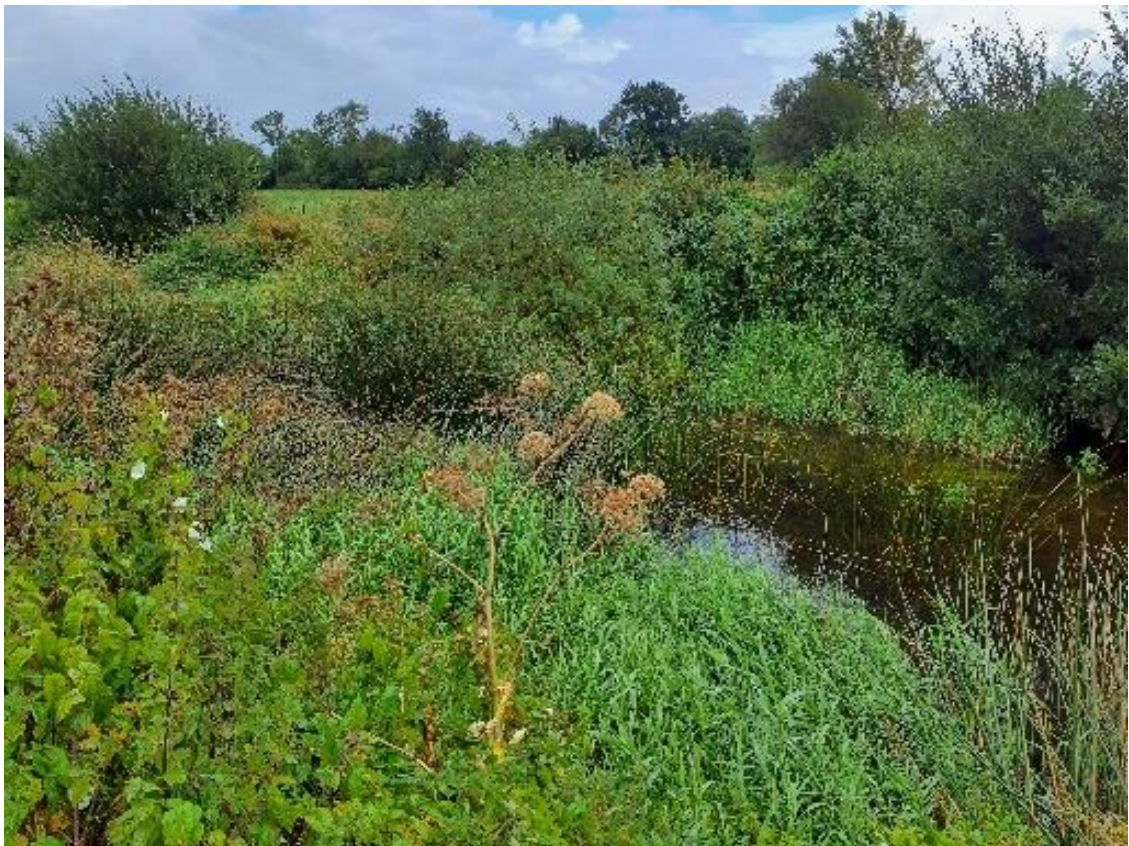
Figure 17: WQ8 in the River Suir

Figure 17, Figure 18 and Figure 19 show the condition of the River Suir for WQ8 sampling point. This sample point had group B indicator species present, which are sensitive of pollutants in the water. This sample point scored a Q value of Q3-4, which means the water quality is moderate. The Water Framework Directive (WFD) status of this sample point is moderate.

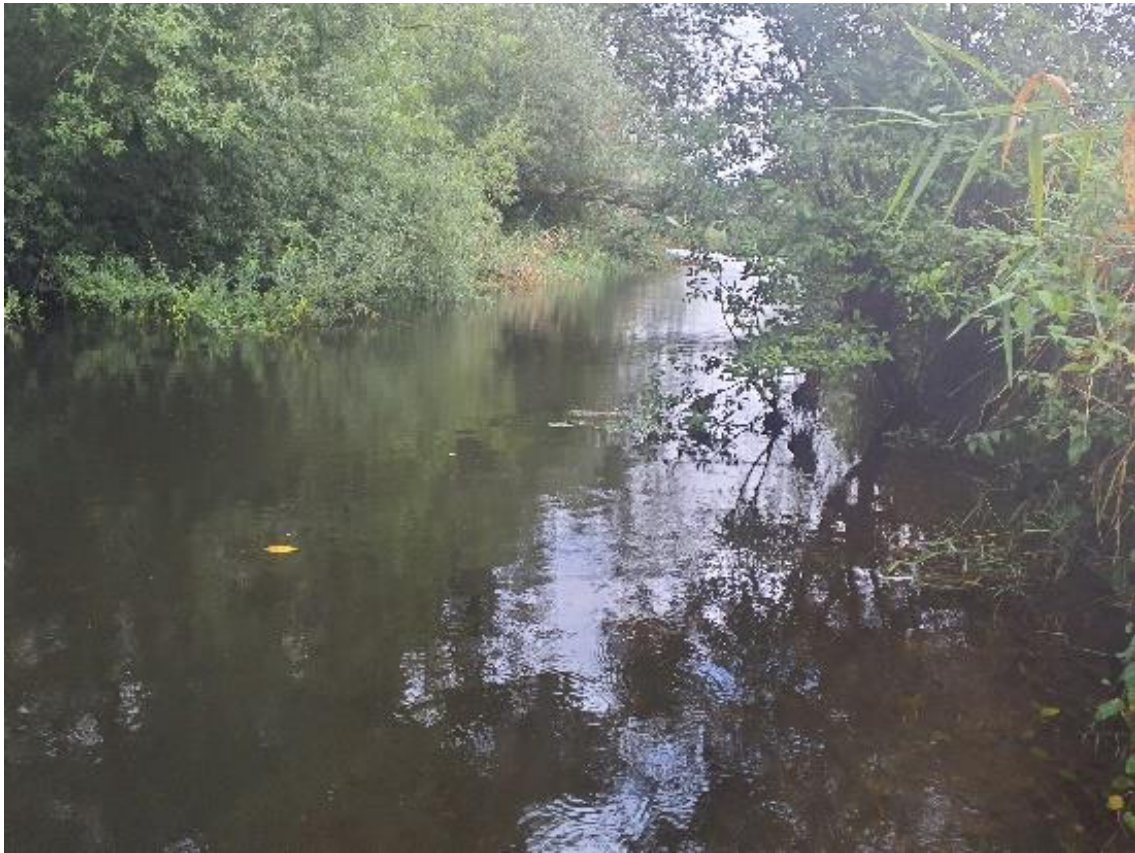
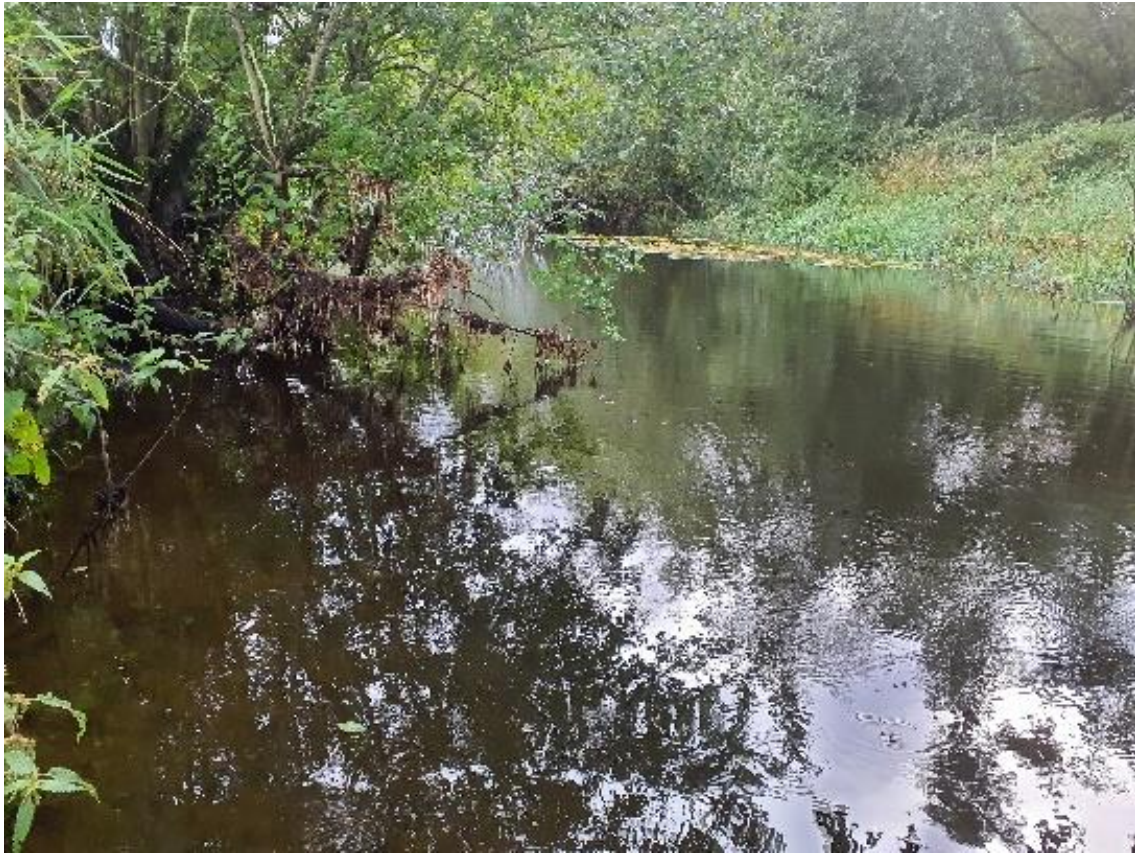
Figure 20: WQ9 in the River Suir

Figure 20 and Figure 21 show the condition of the River Suir for WQ9 sampling point. This sample point had group C indicator species present, which are tolerant of pollutants in the water. This sample point scored a Q value of Q3, which means the water quality is poor. The Water Framework Directive (WFD) status of this sample point is poor.

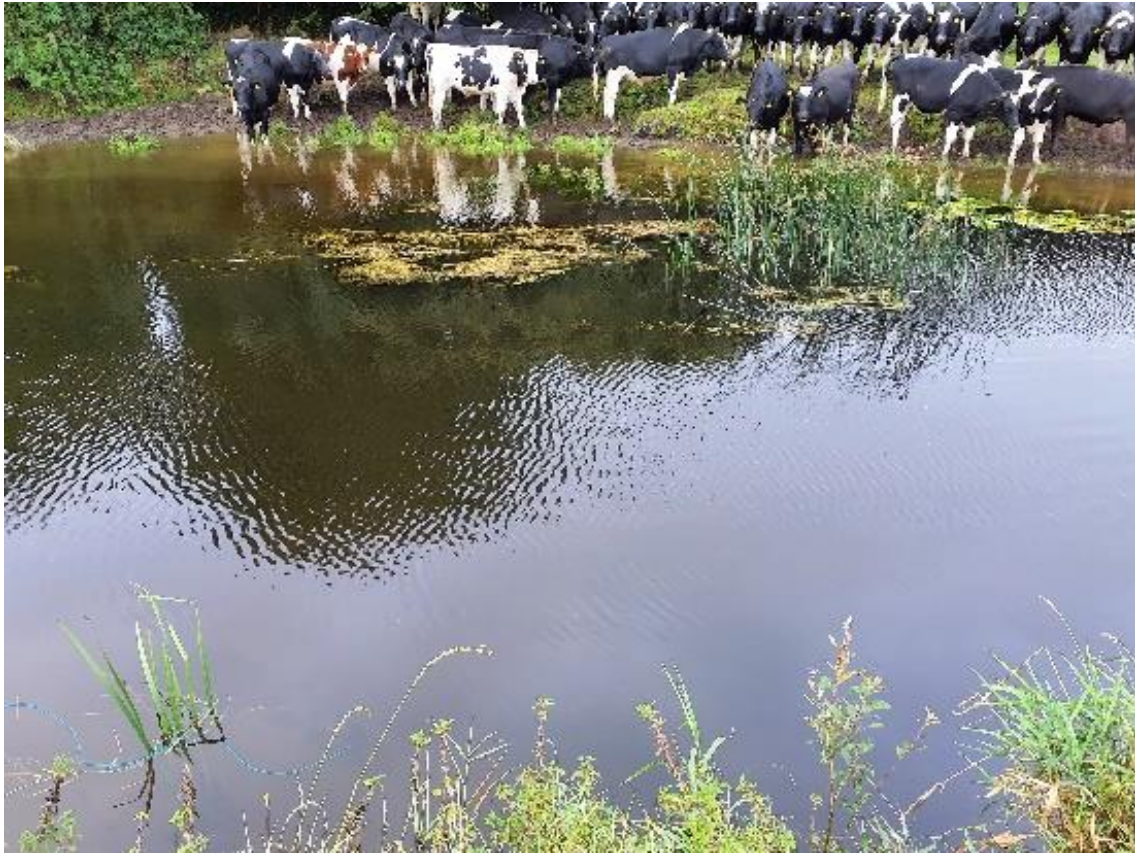
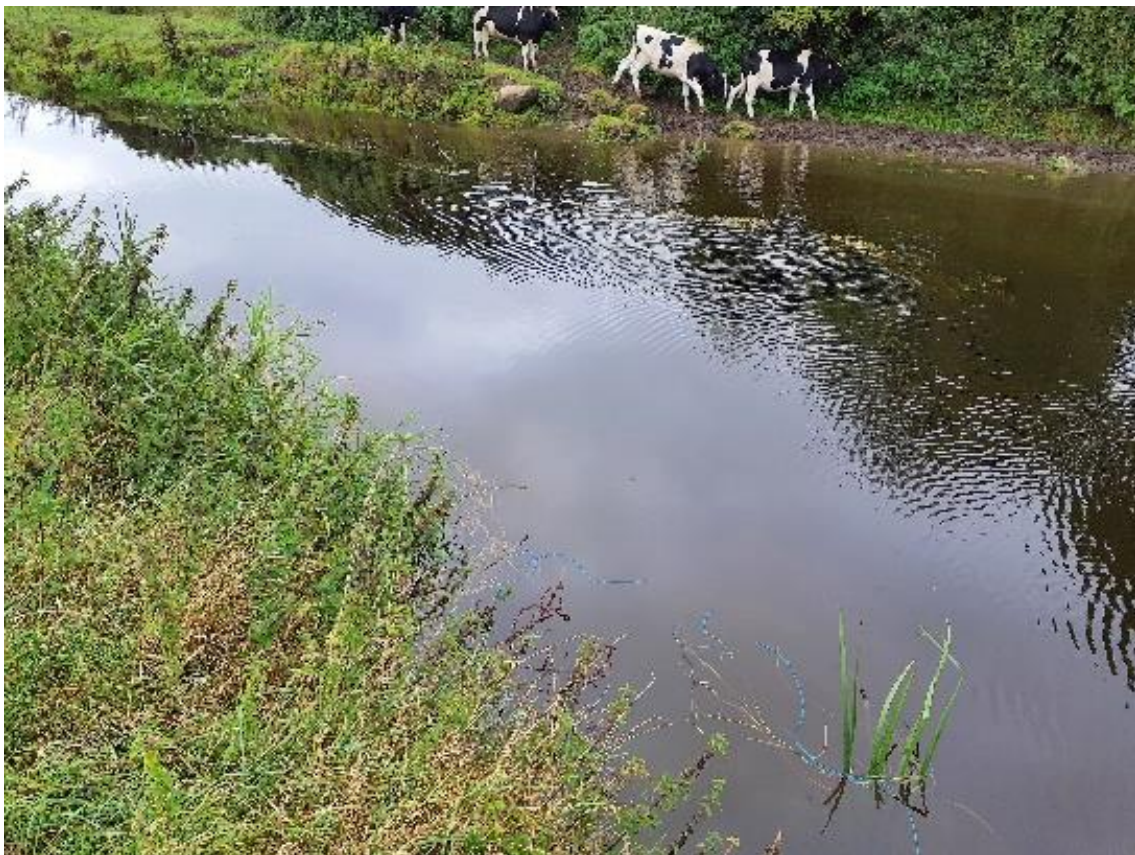
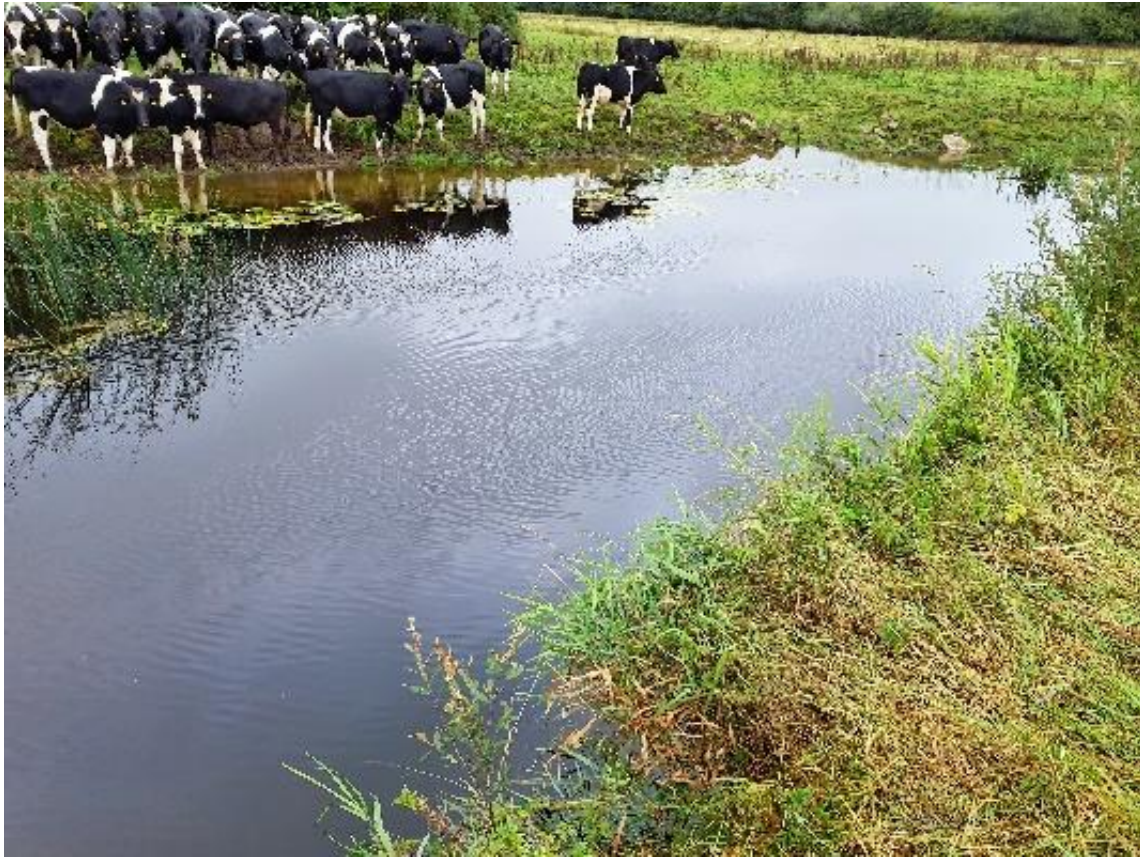
Figure 22: WQ10 in the River Suir

Figure 22, Figure 23 and Figure 24 show the condition of the River Suir for WQ10 sampling point. This sample point had group C indicator species present, which are tolerant of pollutants in the water. This sample point scored a Q value of Q3, which means the water quality is poor. The Water Framework Directive (WFD) status of this sample point is poor.
